Manhole Inspection Summary

Manhole # S17UU1008MH

Insp Date: **5/23/07 1:30 PM**

Location Address: **CYLBURN AVE**

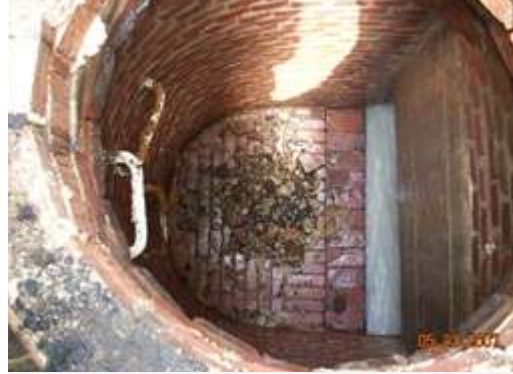
Top View

Corroded steps. Evidence of surcharge - Bench debris.

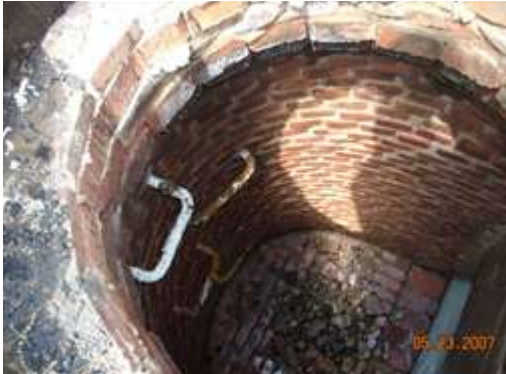
Defect

Frame leaks. Frame offset. Adjustment deterioration and infiltration. Corbel infiltration.

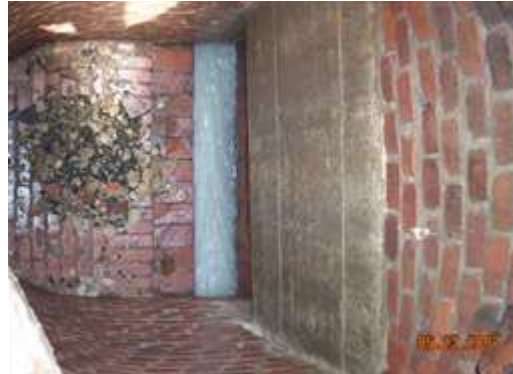
Defect

Adjustment and Corbel infiltration.

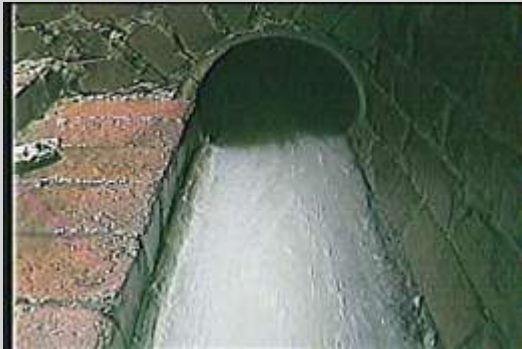
10 in. Circular Gravity Sewer Pipe Out @ 12 O'Clock

Barrel deterioration and infiltration. Channel deterioration.

Pipe Seal Cond: **Cracked**

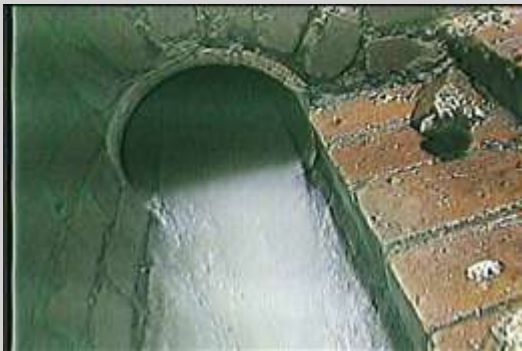
10 in. Circular Gravity Sewer Pipe In @ 6 O'Clock

Pipe Seal Cond: **Cracked**
